MECHANISMS OF THERMAL BARRIER COATING DEGRADATION AND FAILURE

J.T. DeMasi and K.D. Sheffler
Pratt & Whitney Aircraft
East Hartford, Connecticut 06108

This presentation describes the objectives and initial results of a Thermal Barrier Coating (TBC) Life Prediction Model Development Program. The goals of this program, which is sponsored in part by NASA under the HOST (Hot Section Technology) Program, are to:

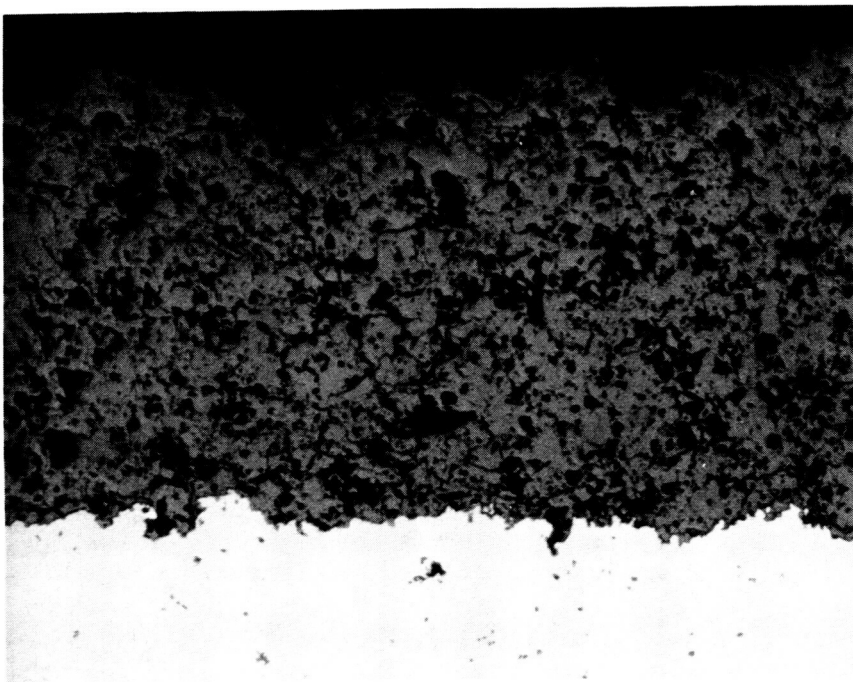
Figure 2.

PWA 264 TWO LAYER THERMAL BARRIER COATING

- PLASMA DEPOSITED YTTRIA PARTIALLY STABILIZED ZIRCONIA
 - CONTROLLED POROSITY, MICROCRACKING
- INCORPORATES RESIDUAL STRESS CONTROL
 - COOL WORKPIECE DURING APPLICATION
- LOW PRESSURE CHAMBER SPRAY BOND COAT
 - OXIDATION RESISTANT MCRALEY COMPOSITION

The coating being studied on this program is a two layer thermal barrier system incorporating a nominal ten mil outer layer of seven percent yttria partially stabilized zirconia plasma deposited over an inner layer of highly oxidation resistant low pressure plasma sprayed NiCoCrAlY bond coating. This coating currently is in flight service on turbine vane platforms in the JT-9D and PW2037 engines and is bill-of-material on turbine vane airfoils in the advanced PW4000 and IAE V2500 engines.

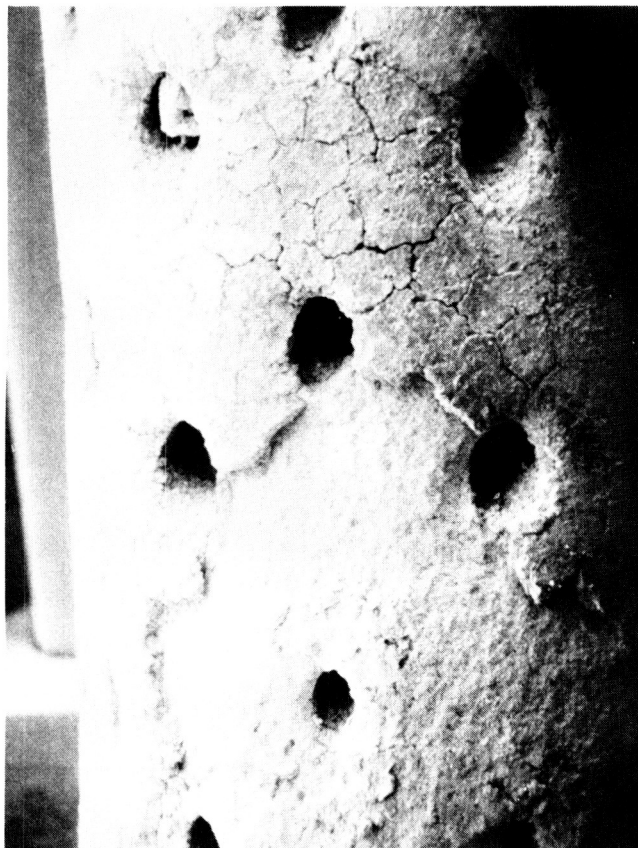
Figure 4.

TYPICAL THERMAL BARRIER COATING FAILURE MODE

An initial review of experimental and flight service components indicates that the predominant mode of TBC failure involves thermomechanical spallation of the ceramic coating layer. This ceramic spallation involves the formation of a dominant crack in the ceramic coating parallel to and closely adjacent to the metal-ceramic interface.

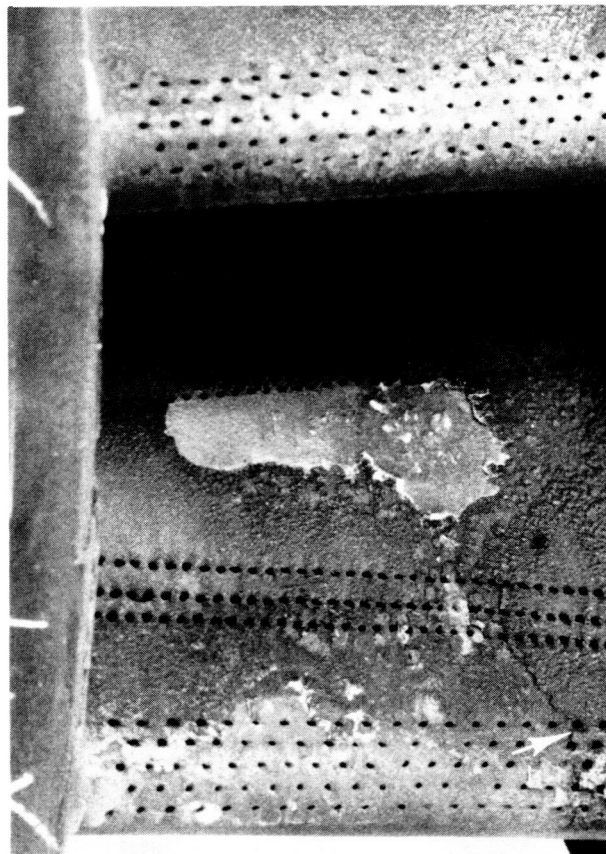
Figure 5.

BOND COAT OXIDATION FAILURE

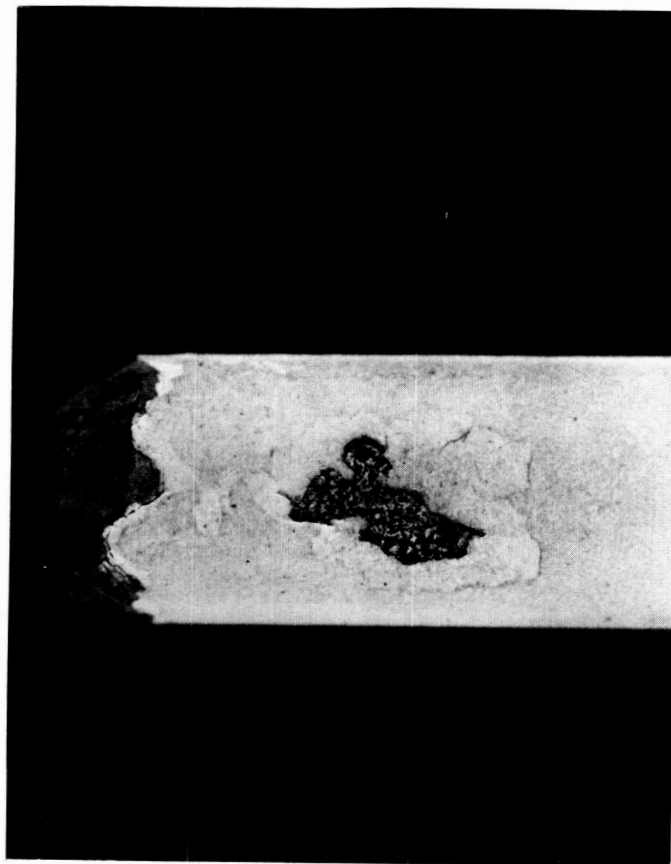
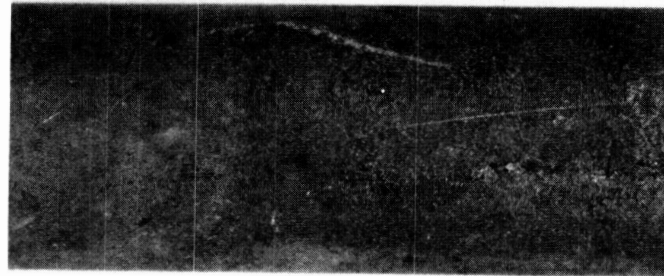
Figure 6.

HOT CORROSION FAILURE OBSERVED ONLY AT HIGH SALT LEVEL (35 PPM)

- NOT OBSERVED TO DATE IN FLIGHT SERVICE

35 PPM

10 PPM

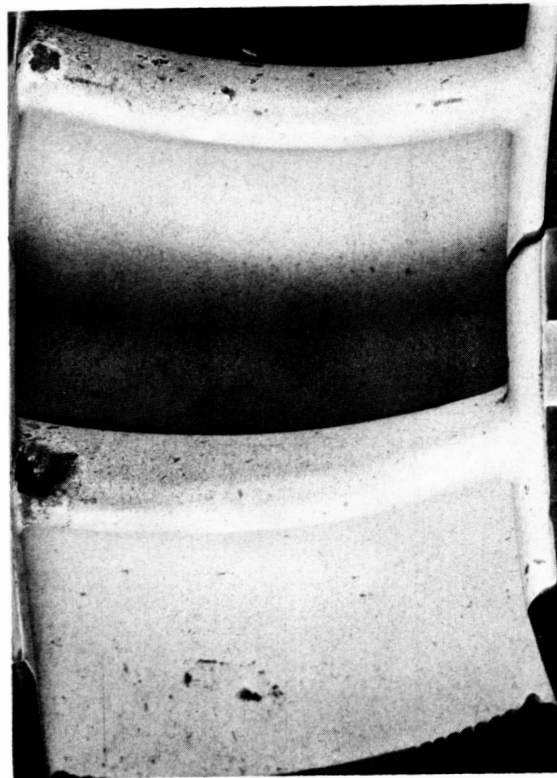
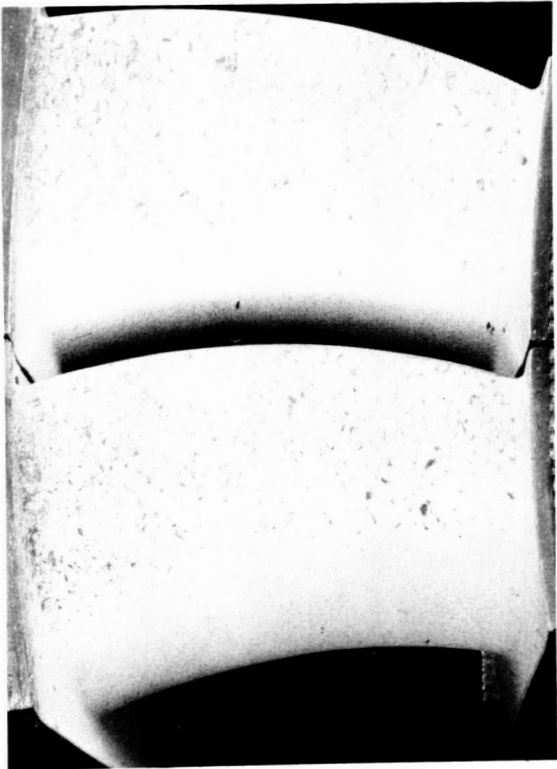
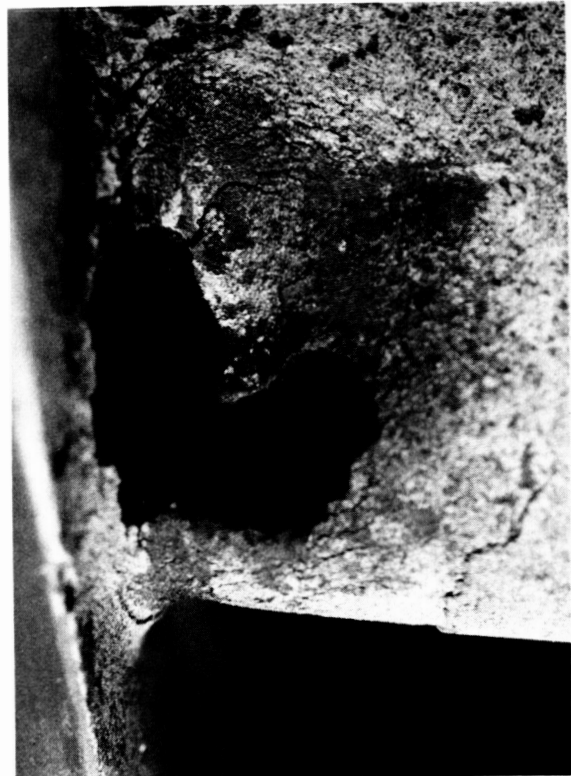
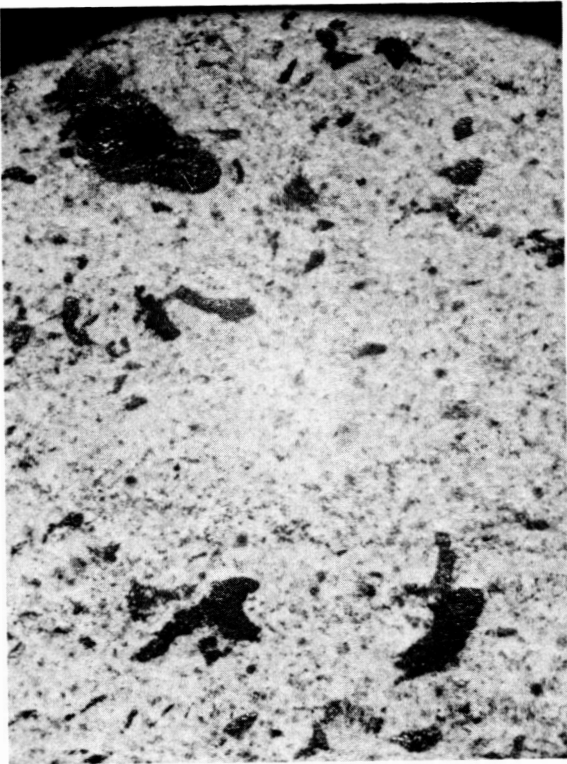
Figure 7.

COATING FOD IS NOT COMPONENT LIFE LIMITING

TURBINE VANE LEADING EDGE

TURBINE VANE TRAILING EDGE

"DAMAGED COATING"

METAL SMEARED ON INTACT COATING

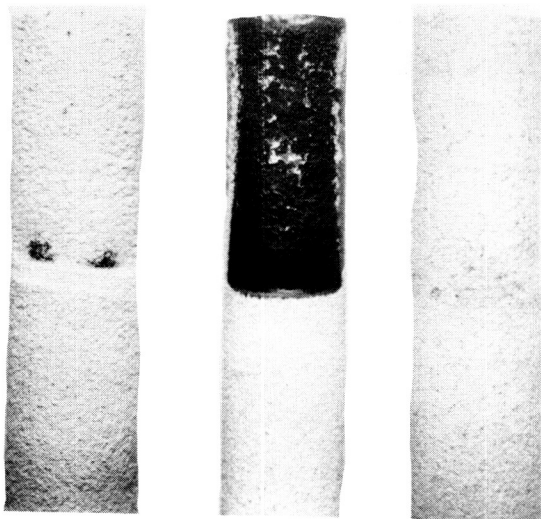
Figure 8.

EROSION

NOT FOUND SO FAR ON ENGINE COMPONENTS

- 21% MgO-ZrO_2 COMBUSTORS
(20 YEARS EXPERIENCE)
- 7% $\text{Y}_2\text{O}_3 - \text{ZrO}_2$ TURBINE COMPONENTS
(3 YEARS EXPERIENCE)

8-10 mils
20% $\text{Y}_2\text{O}_3\text{-ZrO}_2$

1-3 mils
 ZrSiO_4

8-10 mils
6% $\text{Y}_2\text{O}_3\text{-ZrO}_2$

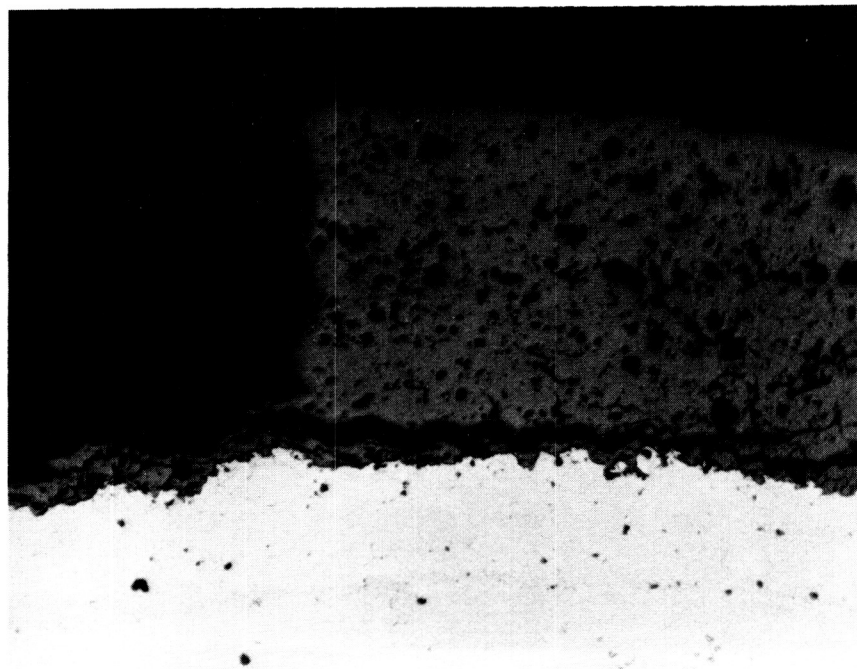
Figure 9.

PREDOMINANT ENGINE FAILURE MODE IS TIME/CYCLE DEPENDENT

CERAMIC CRACKING NEAR METAL INTERFACE

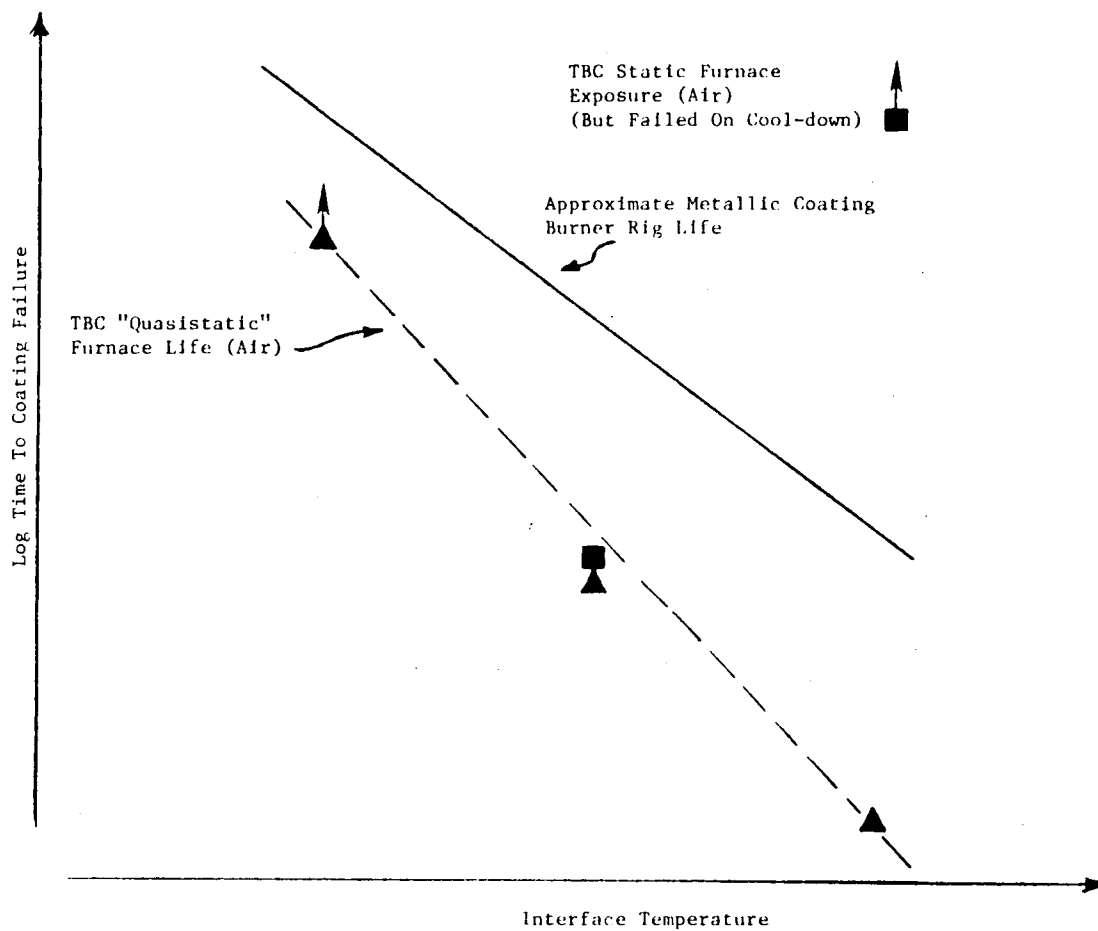
Figure 13.

THERMAL TRANSIENT REQUIRED TO "FAIL" COATING

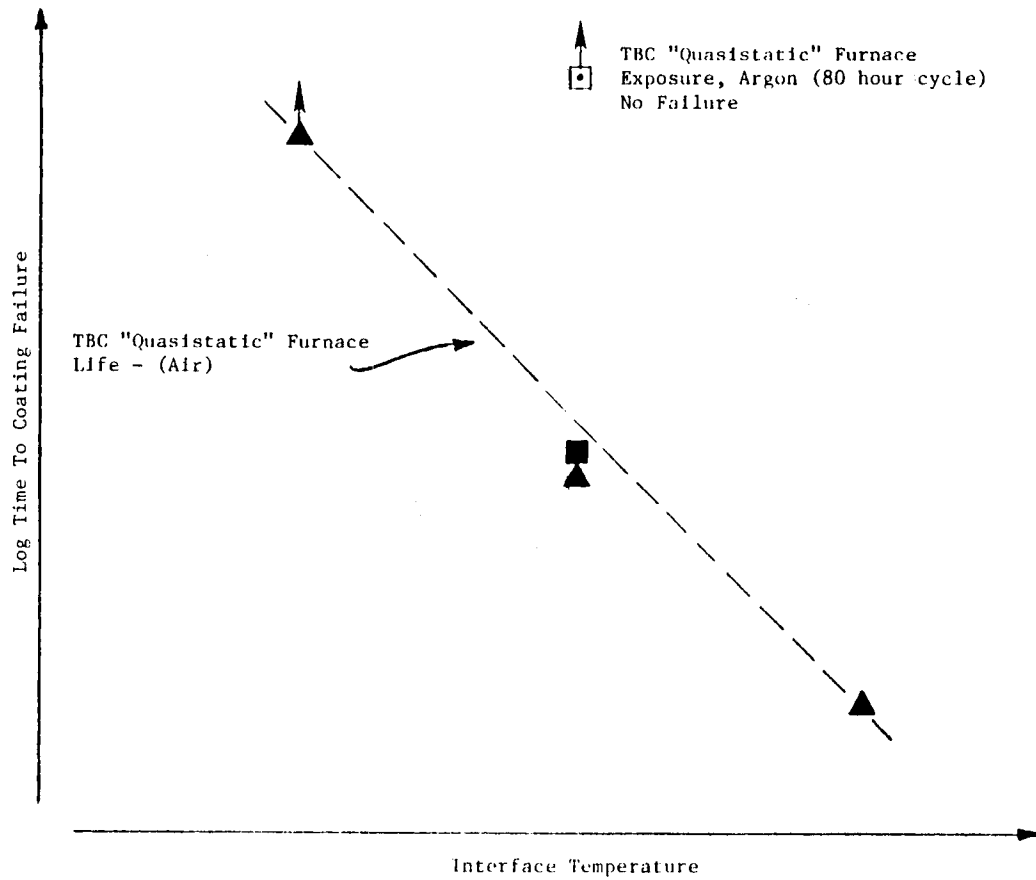
Figure 14.

THERMAL EXPOSURE ATMOSPHERE EFFECTS COATING DURABILITY

Initial results from a laboratory test program designed to study the influence of various "driving forces" such as temperature, thermal cycle frequency, environment, coating thickness, etc. on ceramic coating spalling life appears to confirm the hypothesis initially proposed by Miller (Ref. 1). This hypothesis suggests that bond coat oxidation damage at the metal-ceramic interface contributes significantly to thermomechanical cracking in the ceramic layer. Low cycle rate furnace testing in air and in argon clearly shows a dramatic increase of spalling life in the non-oxidizing environment. At lower

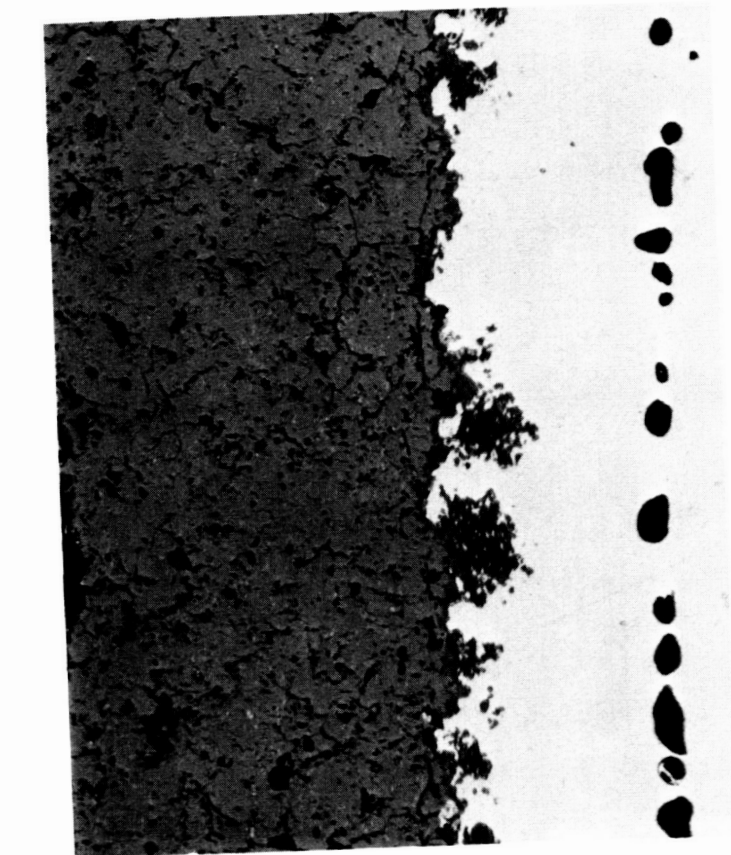
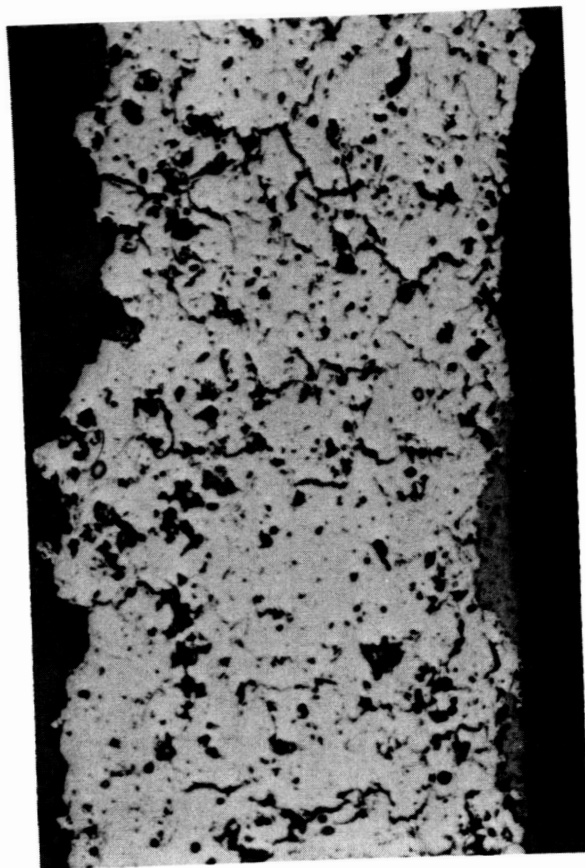
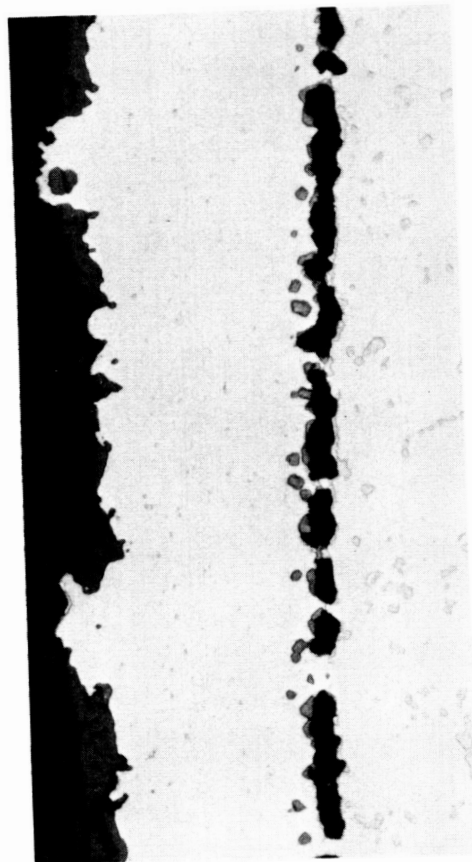
Figure 15.

COATINGS SURVIVE EXTENDED FURNACE EXPOSURE IN ARGON

ARGON

AIR

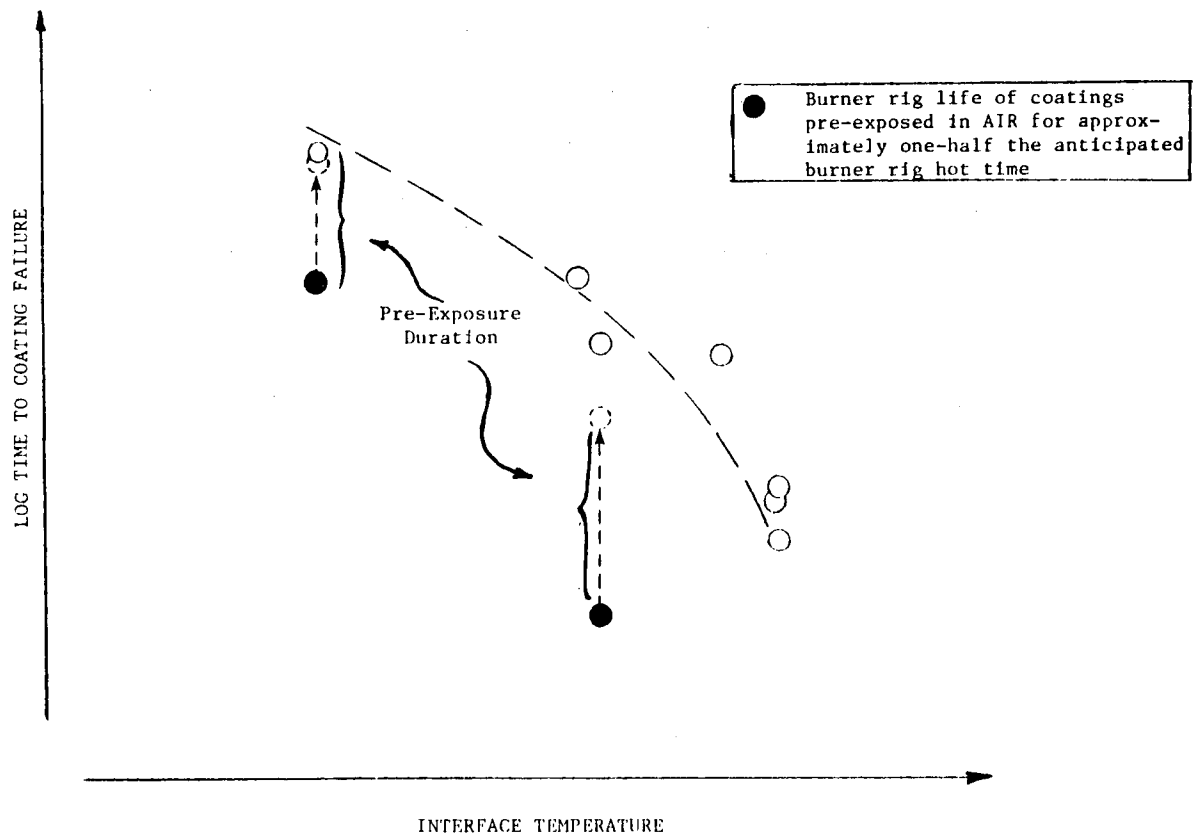
Figure 16.

AIR PRE-EXPOSURE DEGRADES CYCLIC LIFE

temperatures, on the order of 2000°F, elevated temperature pre-exposure of TBC specimens in air causes a proportionate reduction of cyclic thermal spalling life, whereas pre-exposure in argon does not. At higher temperatures, on the order of 2100°F, it appears that additional degradation mode(s) may be operative. Future activity will be devoted to confirming this observation and to identification of additional TBC degradation mode(s).

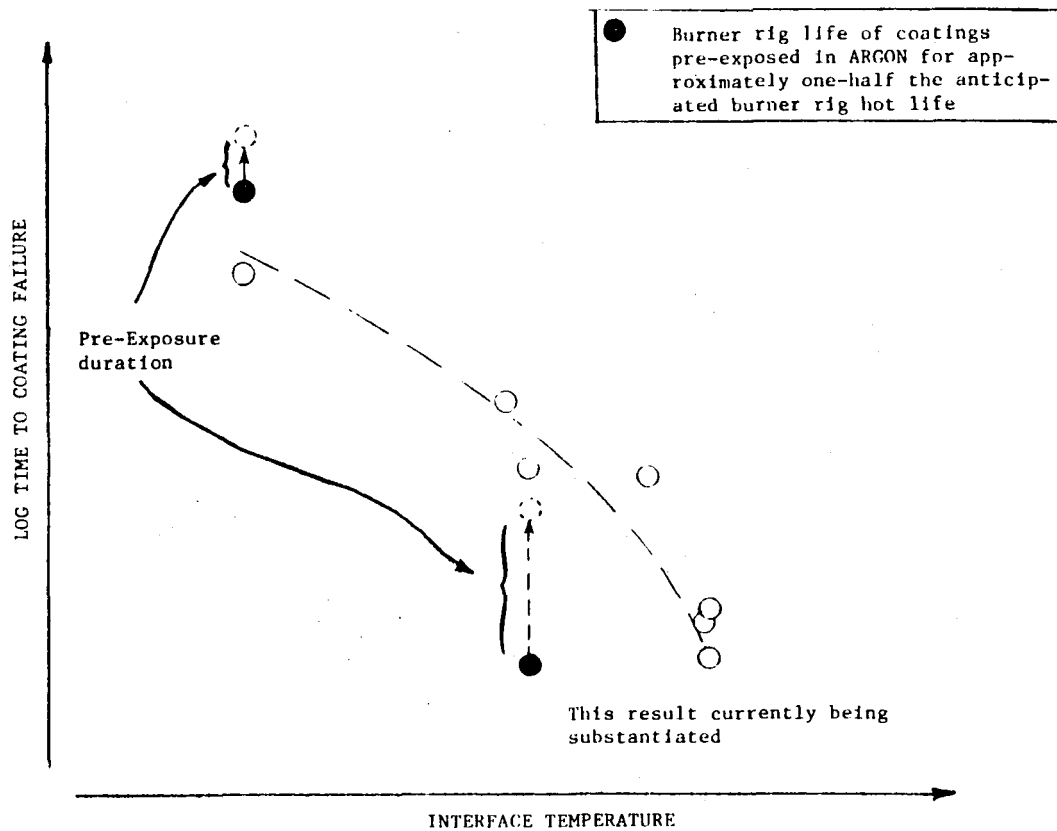
Figure 17.

"INERT" PRE-EXPOSURE EFFECT, APPEARS TO BE TEMPERATURE DEPENDENT

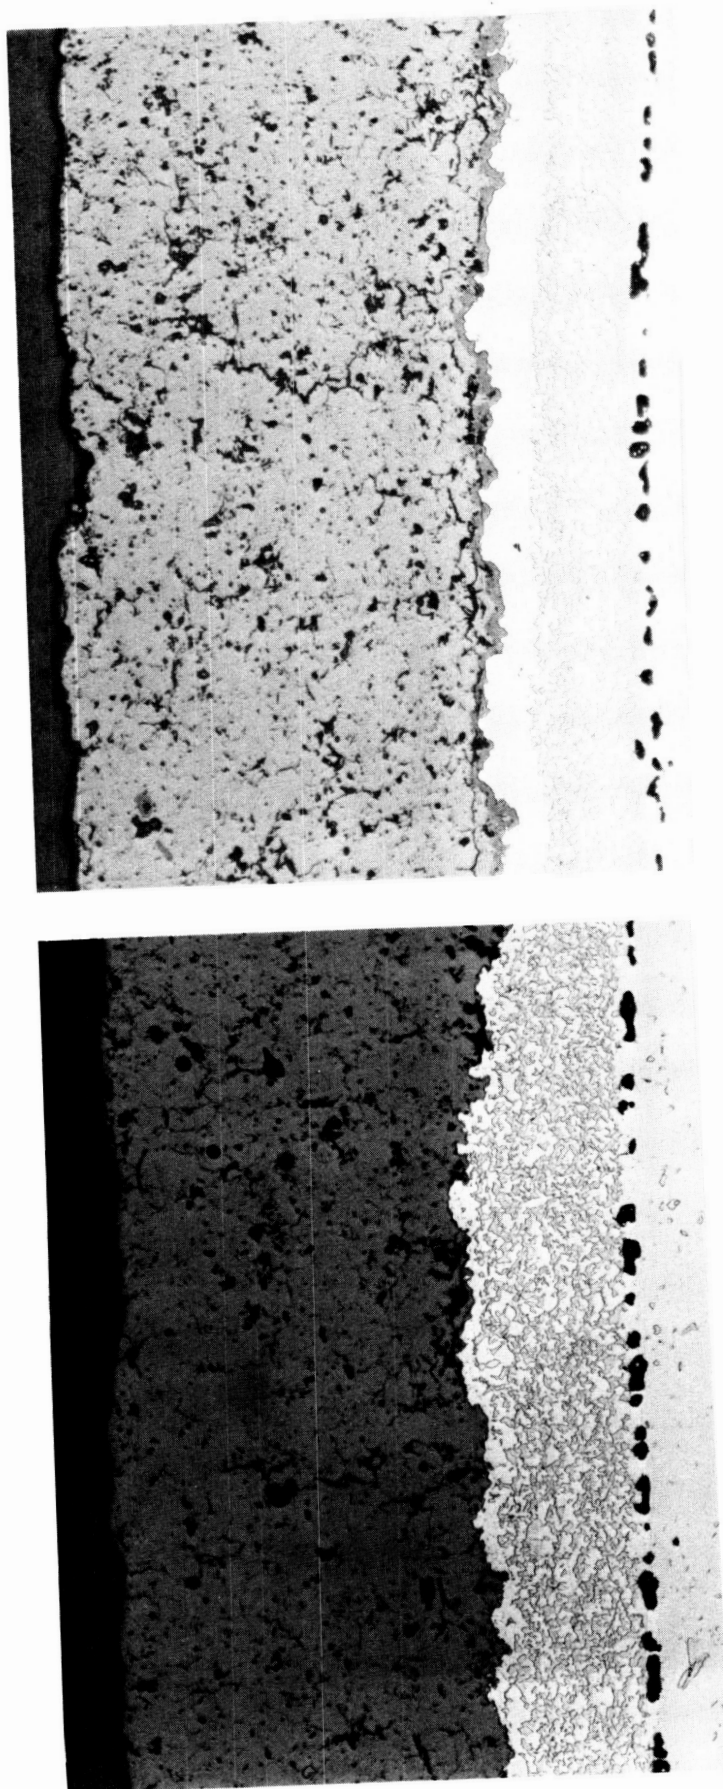
Figure 18.

MICROSTRUCTURAL VARIATIONS FOR PRE-TEST THERMAL EXPOSURE ATMOSPHERES

AIR

ARGON
